# Authenticity in Architectural Conservation: A Review of Conservation works at Monument of Sultan Ibrahim at Makli, Thatta

**Abstract:** Makli is famous for its historical Architecture especially mix use of various materials art work and patterns. The work presented in brick, stone and tile on various parts of the structures are considered as novel pieces of unique art, rendering and masonry. The elegant art and design work in Makli is virtually lying in open sky and being dilapidated day by day. Most of the monuments are in enormous threat of natural and human interactions. The conservation efforts made so far need very careful review and intervention but the situation at site is miserably conducted and authenticity of monument is on stake. In order to maintain the authenticity of the monument, conservation work on Sultan Ibrahim need to be very carefully reviewed and analyzed. The initial observation and pictures of the work illustrates indication of wrong conservation.

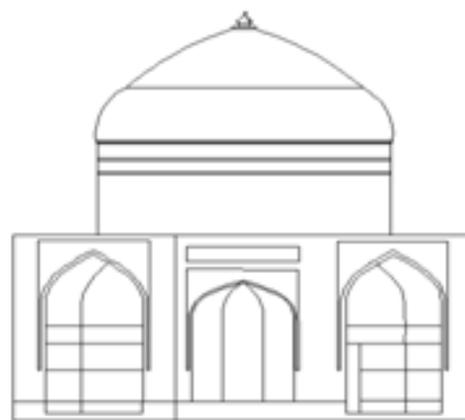
Fig.3 (a) View of tomb sultan Ibrahim tomb

Makli situated in Thatta, Sindh, Pakistan, has status of World Heritage Site that spread over 12 sq km, with a width of around 8 kilometers. Makli hill is the interment place of approximately 125,000 Sufi holy people. The tomb of Mir Sultan Ibrahim and His Sibling Amir Muhammad (1556-1592) fig.1-2, is one of the important places in Makli Thatta that is under discussion [1]. The Makli site disposes as a landmark of vaults, arches, domes and art work of this biggest Muslim necropolises. It is an open theatre and display of ill, broken and ruined monuments. Some of them are still standing very high and some of them are shabby and partially broken and rest of them are totally collapsed and laying down on ground fig # 3a

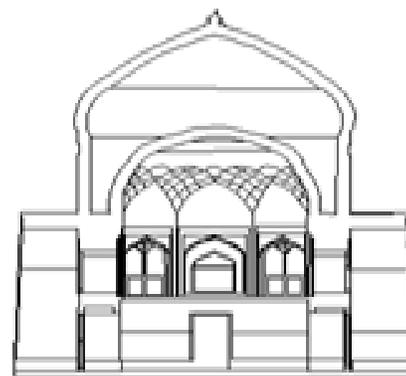
Fig.3,(b) Elevation

This tomb is situated at outskirt of Thatta Makli. Shows the condition of tomb of sultan Ibrahim. This tomb stands in the middle of a rectangular courtyard, measuring 137-ft 7 1/2-in. by 87-ft 10 1/2 in. with arched entrance on the east. The enclosure walls, which are constructed with bricks, have now found fallen but the stone foundations are still standing.fig-3(b) (c).[2]

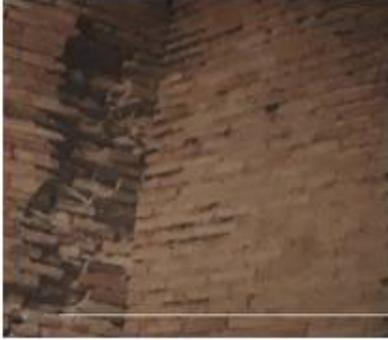
S.No. Photo	Description of condition of Old structure	Comments on the conservation works on the same structure
1	<p>The upper part of the structure showing shabby bricks and bricks in bottom of the structure are eroded.</p>

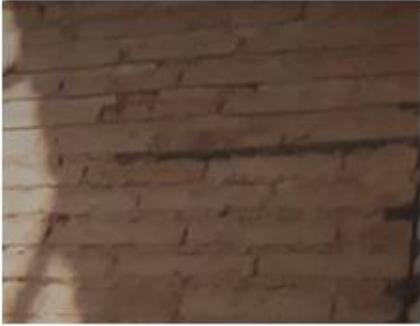
<p>The upper part of the structure is improperly conserved and consolidated where as bottom part of the structure seems pity good and consolidated properly.</p>

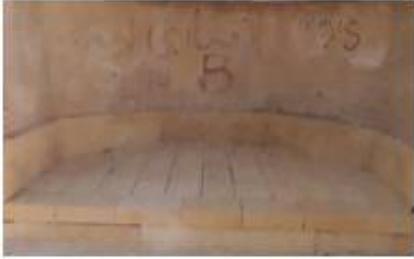
2	<p>The floor is damaged and stone tiles are disintegrated.</p>

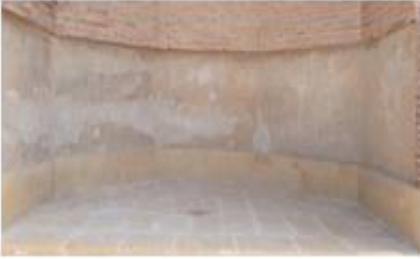
<p>The stone tiles are very badly repaired and the pattern and the bonding material is badly ignored.</p>

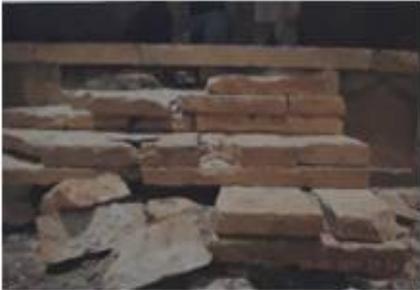
3	<p>The steps leading to platform are totally disintegrated and damaged because of earlier wrong conservation by using cement instead of its original bonding material.</p>

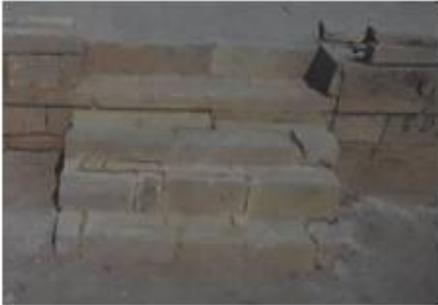
<p>The pattern, masonry and material is highly ignored thus the consolidated part has nothing to do with original thus the act of conservation is more damaging than original disintegrating conditions of the structure.</p>

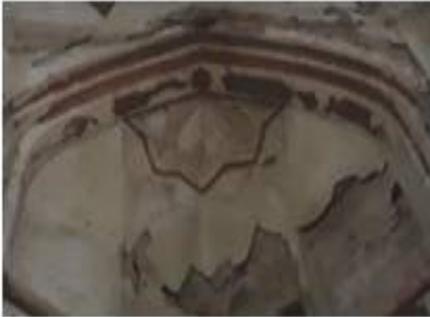
4	<p>This is showing the damaged and disintegrated parts of the inner side of the dome.</p>

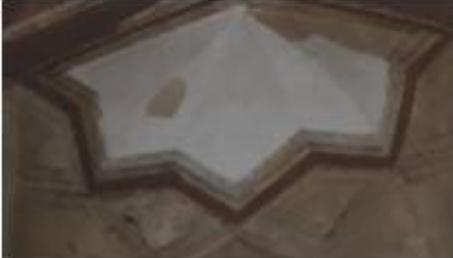
<p>The dome is partially conserved without context thus the act of preservation and conservation seems limited. Moreover the work is unauthentic as the old and new don't resemble each other.</p>

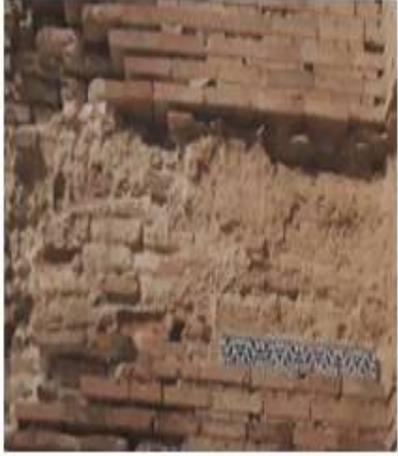
<p>5</p>	<p>Surface of the stucture is eroded and bricks are highly disintergrated.</p>

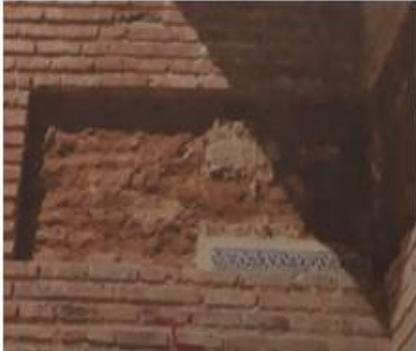
<p>Repair is made without any consideration of bonding and masonry thus this works has nothing to do with the original structure. Father the tile needed to be conserved properly but the same part is not touched this show the non-seriousness and miss management of the conservator.</p>

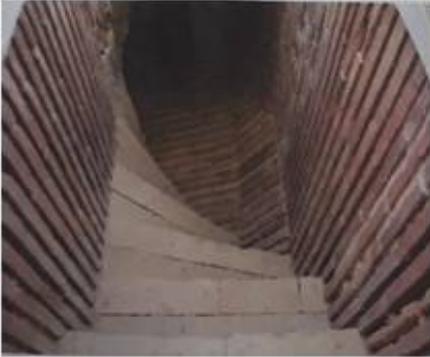
<p>6</p>	<p>This seems already wrongly consrverd but the conditon seems not that bad.</p>

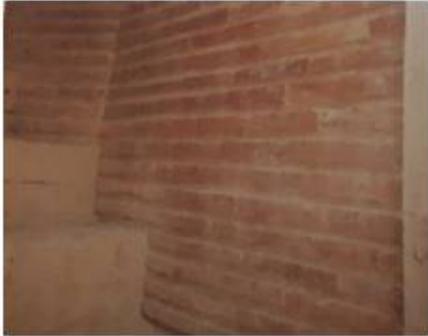
<p>The work of the conservation is totally wrong no research is made on material bonding and appearance of the structure.</p>

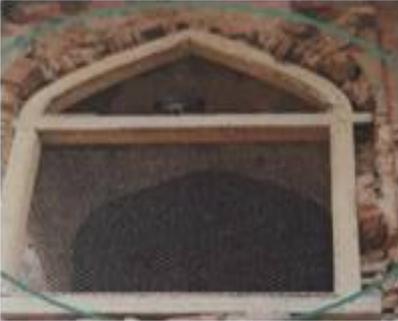
<p>7</p>	<p>The opening is totally dammaged and there are no sign of the original work.</p>

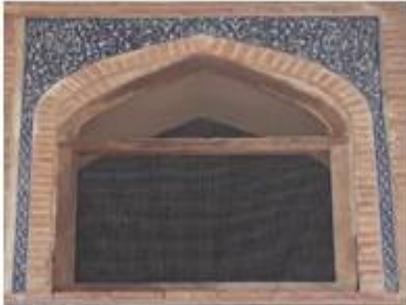
<p>Total conservation work is out of context and nothing to do with original work and the message tagged with the monuments and its part is badly vanished.</p>

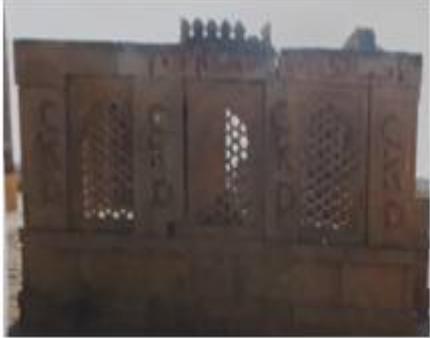
<p>8</p>	<p>Stone wall and lattice is disintegrating.</p>

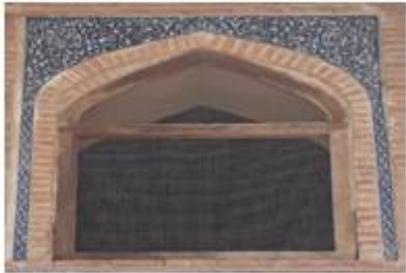
<p>Total conservation work is out of context and nothing to do with original work and the message tagged with the monuments and its part is badly vanished.</p>

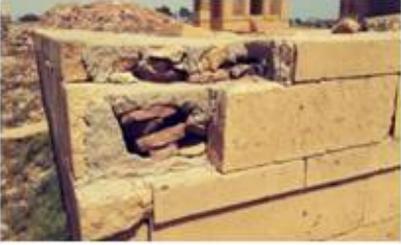
9	<p>Material is fadeout from the platform.</p>

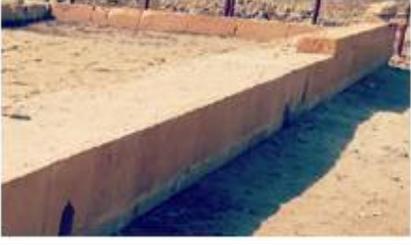
<p>Platform is maintained.</p>

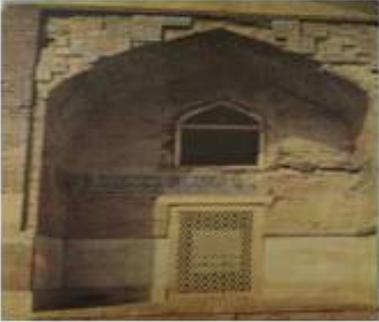
10	<p>The part still carrying its original footings need proper research.</p>

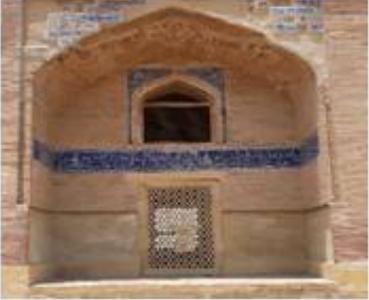
<p>Un-authentic work is done, and the major work is leftover thus such type of partial conservation work is a huge mismanage on part of conservation team.</p>
